L i s a E d d e n
Consulting Structural Engineer
Ballyknockan, Vallemount, Co. Wicklow
Tel/fax 045 867 484 e-mail lisaedden@eircom.net

Structural Engineering Report on the
Metal Bridge, Lower Road,
Strawberry Beds, Co. Dublin
for Fingal County Council

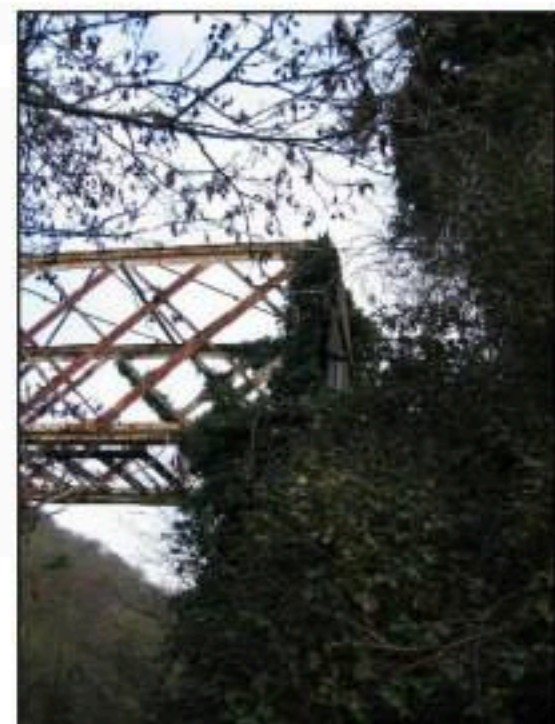
South Abutment, note ivy

The south abutment although less majestic has an onerous task standing in the waters of the Liffey. An assessment of the condition of this abutment was not undertaken as part of this initial investigation. However it should be assumed that there is likely to be root damage from the copious ivy encompassing the structure and also scour of the masonry joints, stones themselves and possibly the base of the structure below water level.

- **Plant growth** - The bridge abutments to both north and south side of river should be cleared of plant growth. Plants should be clipped back not pulled from the structure and further inspection arranged. A minimum of three trees nearest the north abutment should be felled to prevent risk of damage to the masonry tower. The prolific growth beneath the bridge between the river road and the river should be cleared as it is already growing up through the deck beams to the bridge. The gatehouse should also be carefully cleared of all plant growth to allow further inspection and understanding

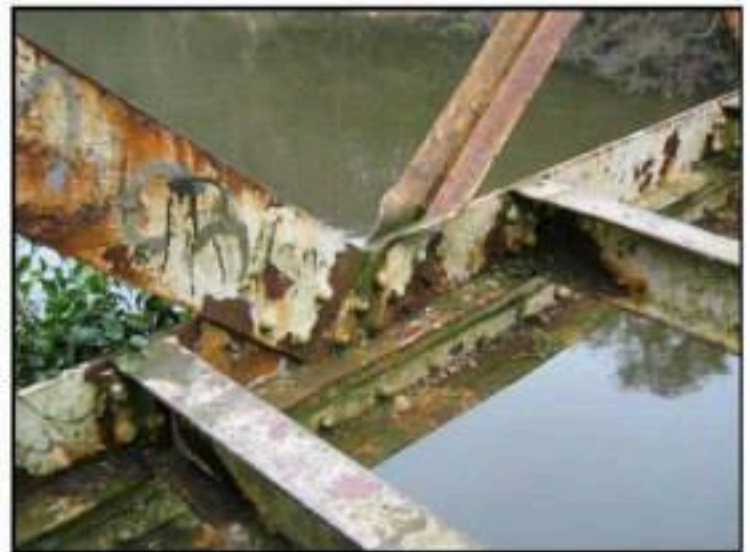
Detail of bottom boom and deck beam connection

The corrosion may also be as a result of the deck construction detail. Although little remains in place it is likely that the deck took the form of a "filler joist floor" over the central section, with some other material such as timber to the sides. There is an indication of loadings from "concrete" on a contemporary temporary works drawing and there are the remains of a clinker type concrete between the central section of some of the deck beam flanges.

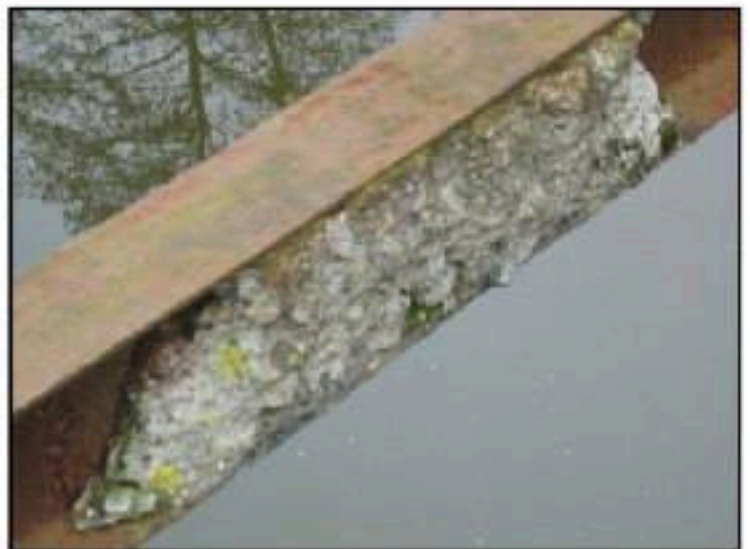
Detail of clinker concrete between deck beams

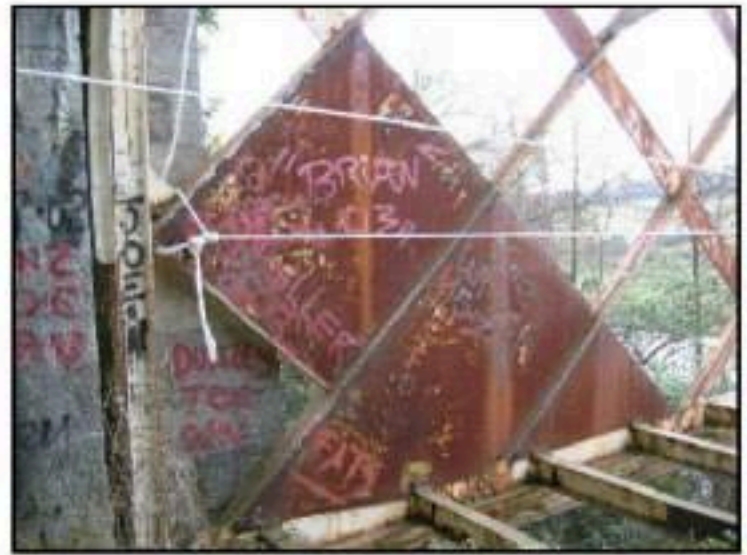
There are some later ferrous elements that were added to the bridge in more recent years. These are the mild steel sheets to the last bays at the north end of the bridge, the gate to the north abutment and the screen to the south end of the bridge. All of these elements have been erected for security reasons and do not form part, nor are they necessary to the structural performance of the bridge

Later steel security sheeting welded to girders

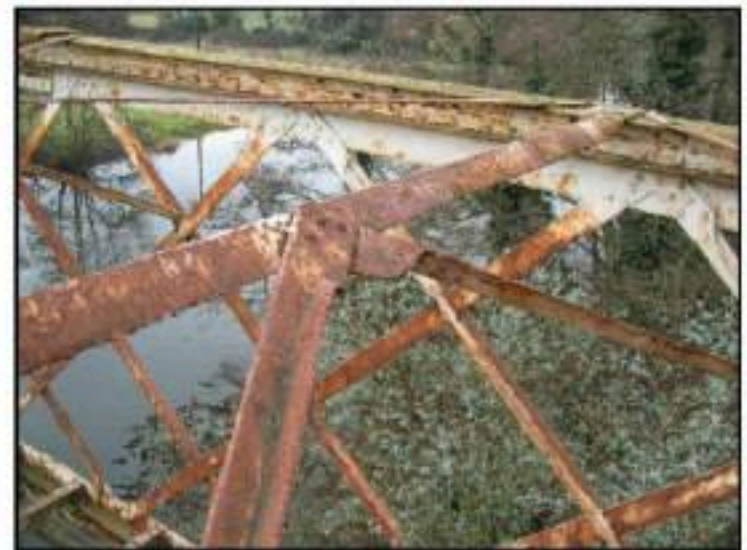
The condition of the bridge metalwork appears very alarming on first glance as the whole structure has been stained dark orange-brown by the corrosion of the ferrous metal. The remaining remnants of the paintwork are flaking and in many locations give the appearance of distorted metal. However all of the main structural elements retain most if not all of their section. There are local pockets only where the sections are pitted but there has not been any substantially loss of section to the main structural elements.

Bracing detail between top of girders

- **Removal of paint and re-painting** – For the effective long term protection of the bridge metalwork the removal of the defective flaking paintwork and repainting is essential. A full scale grit blasting and re-painting of all the metalwork to the bridge should be commissioned. This is a large scale project requiring a carefully brief and project management.

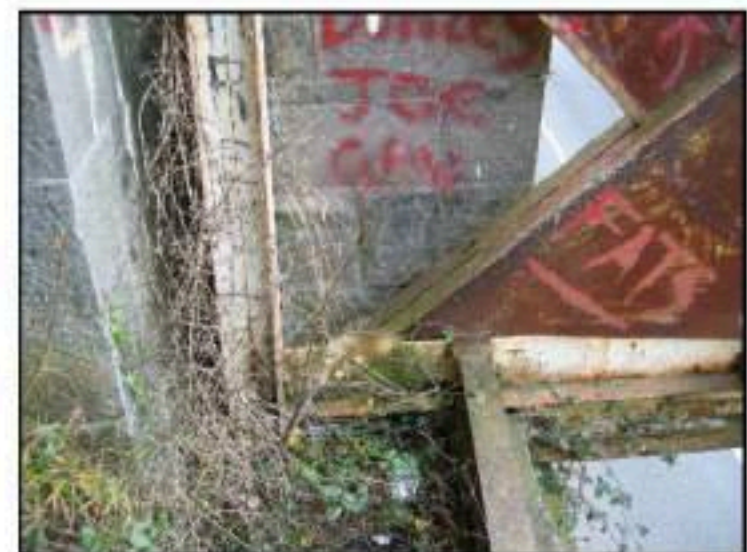
However the four bridge bearing points are suspected to be suffering from significant corrosion. The underside of the bottom girders at the supports and the bearing details in the same location can not be seen because of the build up of debris, however it should be assumed that there has been deterioration at these points because of both their location at the base of the structure and the build up of debris.

Bridge bearing detail at North Abutment

- **Bearings** - The bearings of the two truss girders need to be exposed and assessed as part of the on going inspection and understanding of the bridge. These should be cleared of debris and the area washed down with a water hose or similar. Further inspection by an engineer should be arranged.

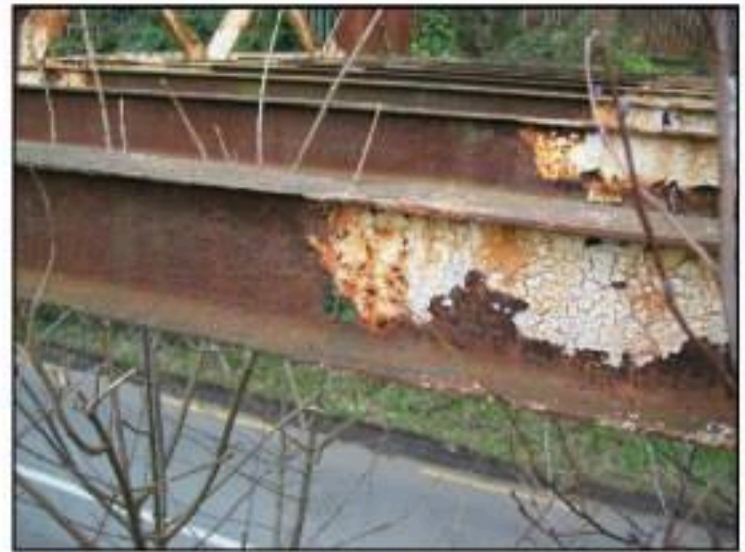
The bridge deck beams have also in places corroded to such an extent that holes have formed through the sections. The corrosion is particularly significant in the locations where the original clinker concrete stopped and thus where possibly water on the deck drained off around the beams.

Deck beams, note corrosion of both flanges and web

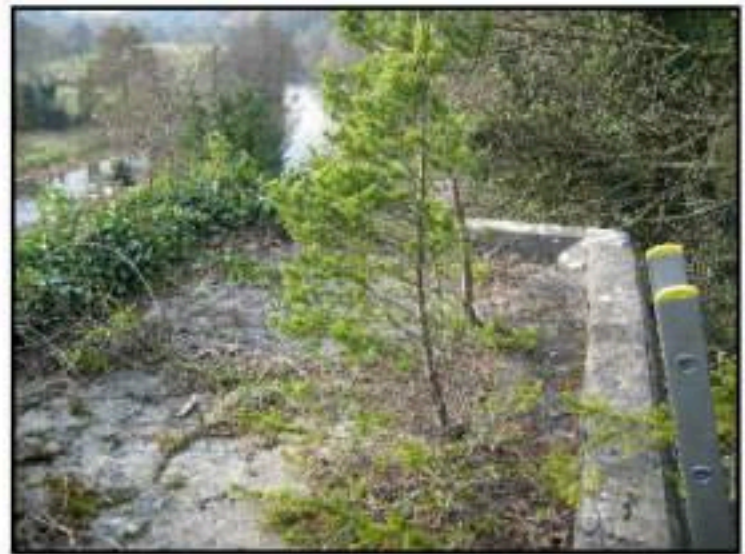
The bridge abutment to the north end of the bridge is in relatively good condition. The structure is substantial and is likely to be well founded. However there is serious deterioration of the roof and in time this will reflect on the rest of the building. There are substantial trees growing from the roof top concrete and the stonework to the underside is showing signs of dampness and the wall tops are showing signs of salt migration. There are many tall conifers within very close proximity of the tower. These trees put the tower at risk of damage should they fall.

North abutment – roof garden

- **Roof to North Abutment** – The roof to the tower of the north abutment is leaking and will need replacement / addition to reduce the water damage that is occurring to the upper levels of stonework. A renewed roof covering will also tend to halt the number of plants and trees that are seeding themselves into the cracks and crevices in the current roof finishes.
- **Inspection of south abutment** – To fully inspect the south abutment not only does the plant growth need to be removed (see above) but also access to the river side of the abutment is required. Viewing of the below water level stonework is a further issue and would need to be coordinated with either a temporary reduction in river level and /or an inspection by a qualified diving team.

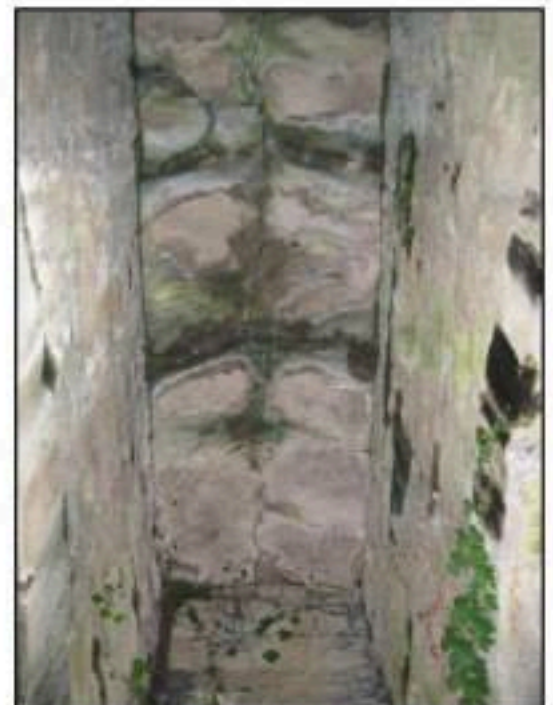
North abutment u/s roof, note rwdp in corner

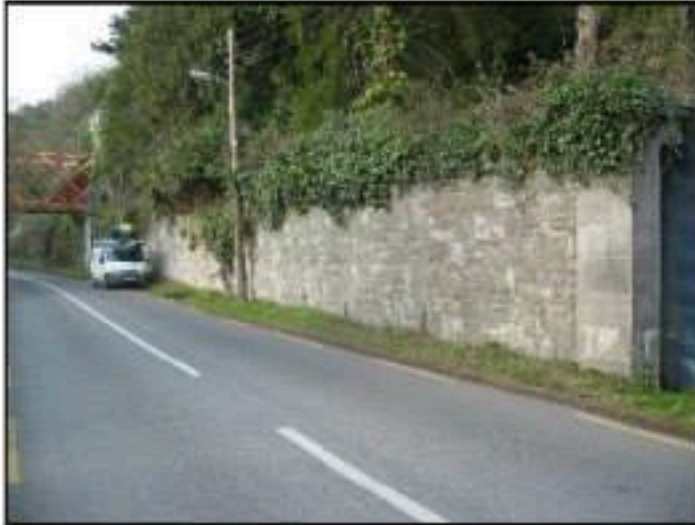
The north bridge abutment joins with a substantial retaining wall that runs approximately 50metres to the east to the access gate way. There are no immediate signs of distress to this wall but there is much ivy growing over the wall and substantial trees growing very close to the upper retaining part of the wall. The gate way is 3020mm wide between substantial dressed limestone piers.

Retaining wall to north abutment approach

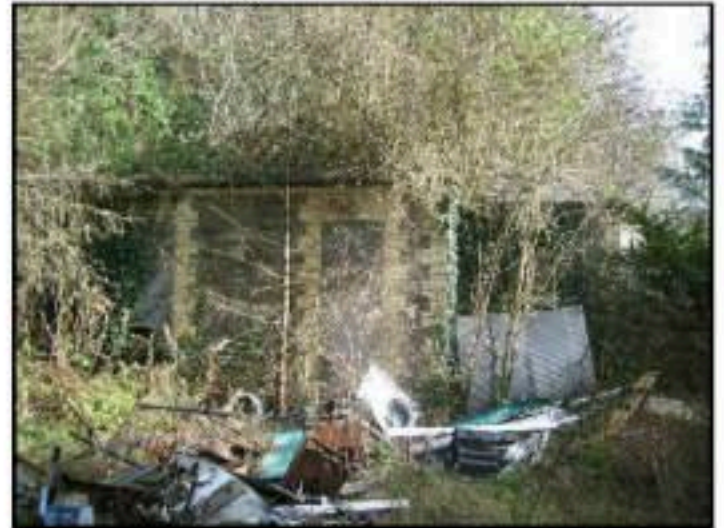
The gatehouse is of modest plan, single storey and constructed of yellow brick and limestone masonry. There are the remains of some timber windows and joinery. The roof was of timber pitched construction and finished in slate. This house is in a state of severe dereliction. It has many trees growing from within and out its walls. Access is extremely difficult at present thus proper investigation is not possible – however it can be assumed that at best the walls alone are salvageable

Gatehouse to east of north abutment

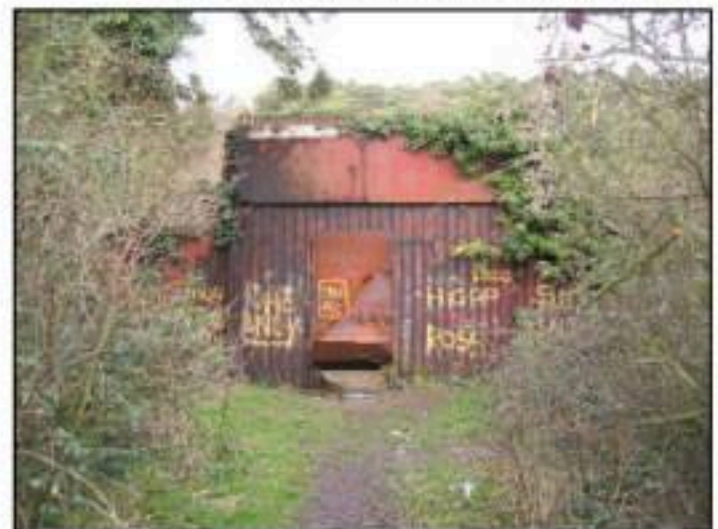
To the south end of the bridge the approach climbs a steep earthen embankment from the river flood plains. The bridge has security metal work welded to its southern metal arch that unfortunately is not successful from either an aesthetic point of view nor as security.

"Security" sheeting to south end of bridge

- **Security** - The bridge is not secure to public access. The security metal work to the south end in particular is insecure and readily accessible to the children who use the park to the south. For health and safety reasons access to the bridge by the public needs to be halted.

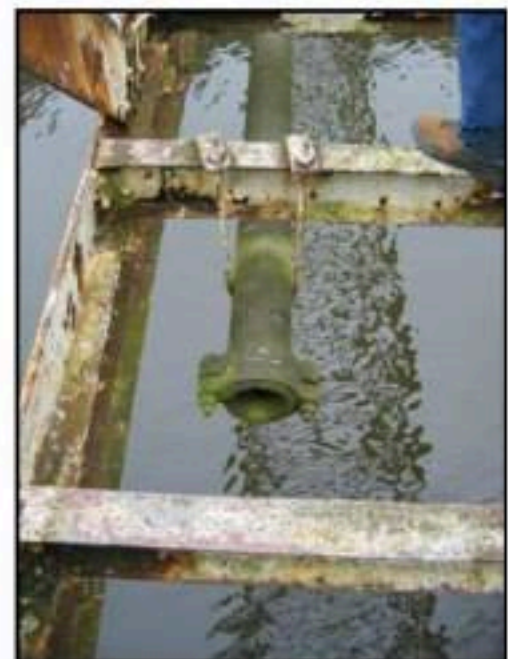
Redundant pipe

Note the pipe that is suspended under the bridge is redundant and could be removed at the start of a painting contract

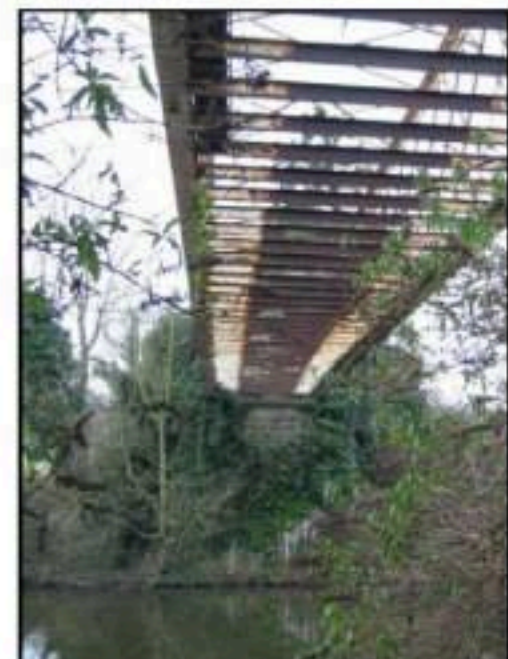
South Abutment viewed from north bank
