L i s a E d d e n
Consulting Structural Engineer
Ballyknockan, Vallemount, Co. Wicklow
Tel/fax 045 867 484 e-mail lisaedden@eircom.net

Structural Engineering Report on the
Metal Bridge, Lower Road,
Strawberry Beds, Co. Dublin
for Fingal County Council

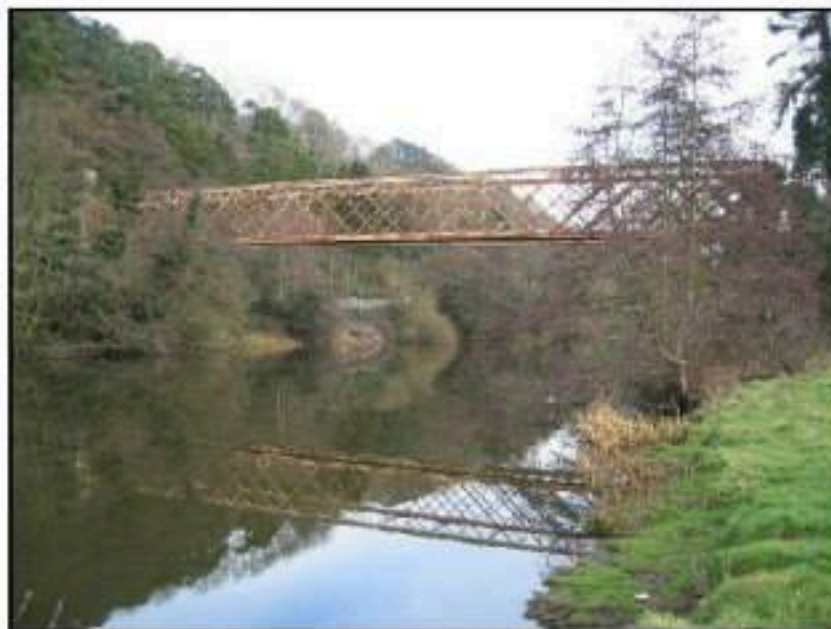
View of bridge from south bank looking east

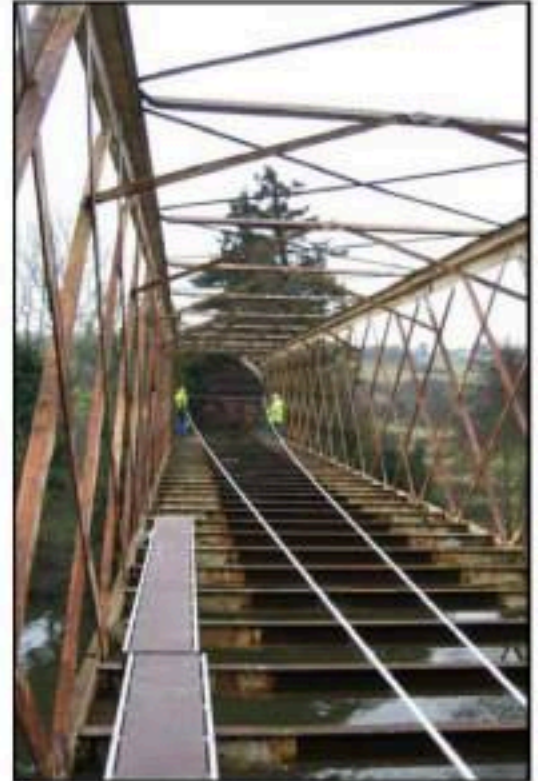
Bridge deck looking south

The girders are set apart 4 metres and connected with bracing at their tops and deck beams at 950mm centres to the base. The decking to the bridge appears to have been of concrete in-fill between the floor beams but is only present in traces. The bridge was once painted white (and possibly even silver) but now is much discoloured by rust.

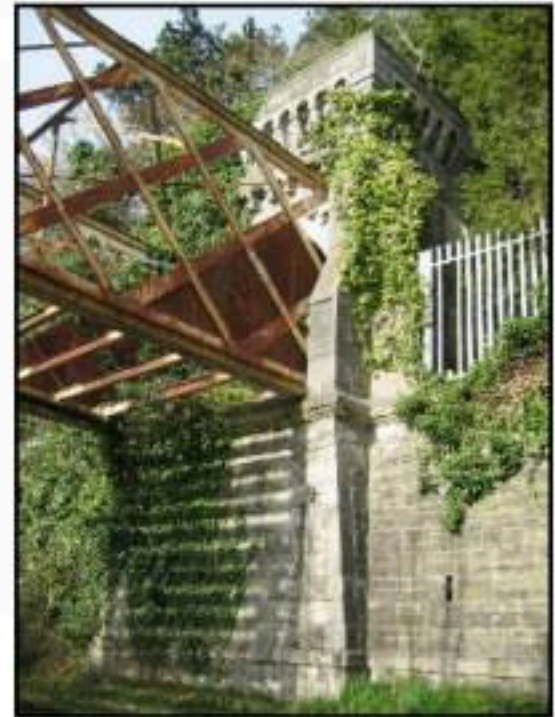
North abutment tower

The bridge abutment to the north end of the bridge is in relatively good condition. The structure is substantial and is likely to be well founded. However there is serious deterioration of the roof and in time this will reflect on the rest of the building. There are substantial trees growing from the roof top concrete and the stonework to the underside is showing signs of dampness and the wall tops are showing signs of salt migration. There are many tall conifers within very close proximity of the tower. These trees put the tower at risk of damage should they fall.

- **Roof to North Abutment** – The roof to the tower of the north abutment is leaking and will need replacement / addition to reduce the water damage that is occurring to the upper levels of stonework. A renewed roof covering will also tend to halt the number of plants and trees that are seeding themselves into the cracks and crevices in the current roof finishes.
- **Inspection of south abutment** – To fully inspect the south abutment not only does the plant growth need to be removed (see above) but also access to the river side of the abutment is required. Viewing of the below water level stonework is a further issue and would need to be coordinated with either a temporary reduction in river level and /or an inspection by a qualified diving team.

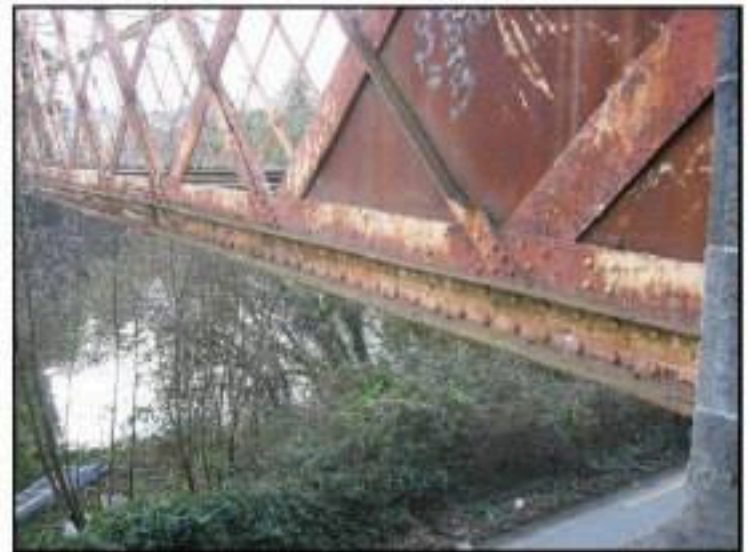
South girder bottom boom at north abutment

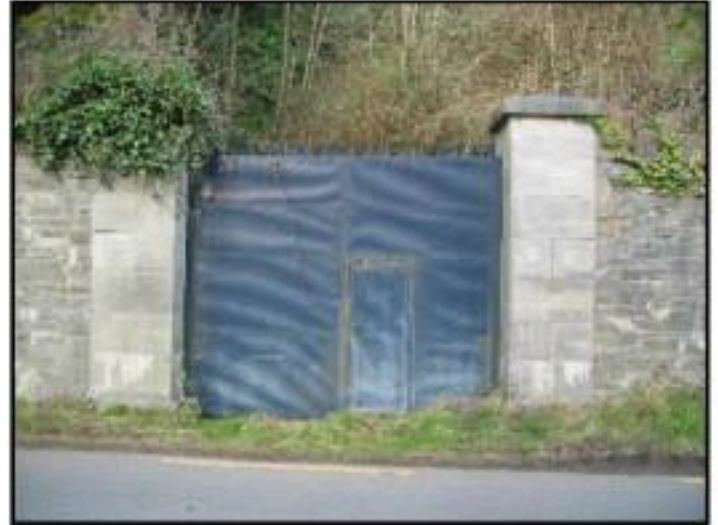
The north bridge abutment joins with a substantial retaining wall that runs approximately 50metres to the east to the access gate way. There are no immediate signs of distress to this wall but there is much ivy growing over the wall and substantial trees growing very close to the upper retaining part of the wall. The gate way is 3020mm wide between substantial dressed limestone piers.

Gateway to gate house

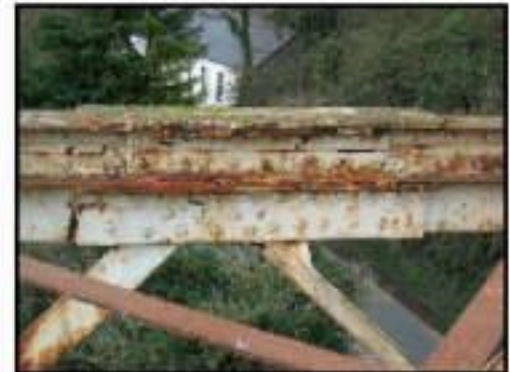
Splice detail top boom
